**OPERATION OF A FORCED CIRCULATION,
CROLOY 9 M, MERCURY LOOP TO STUDY
CORROSION PRODUCT SEPARATION TECHNIQUES**

by D. B. Cooper and E. J. Vargo

Prepared under Contract No. NAS 3-2538 by
THOMPSON RAMO WOOLDRIDGE, INC.
Cleveland, Ohio

NATIONAL AERONAUTICS AND SPACE ADMINISTRATION • WASHINGTON, D. C. • APRIL 1965

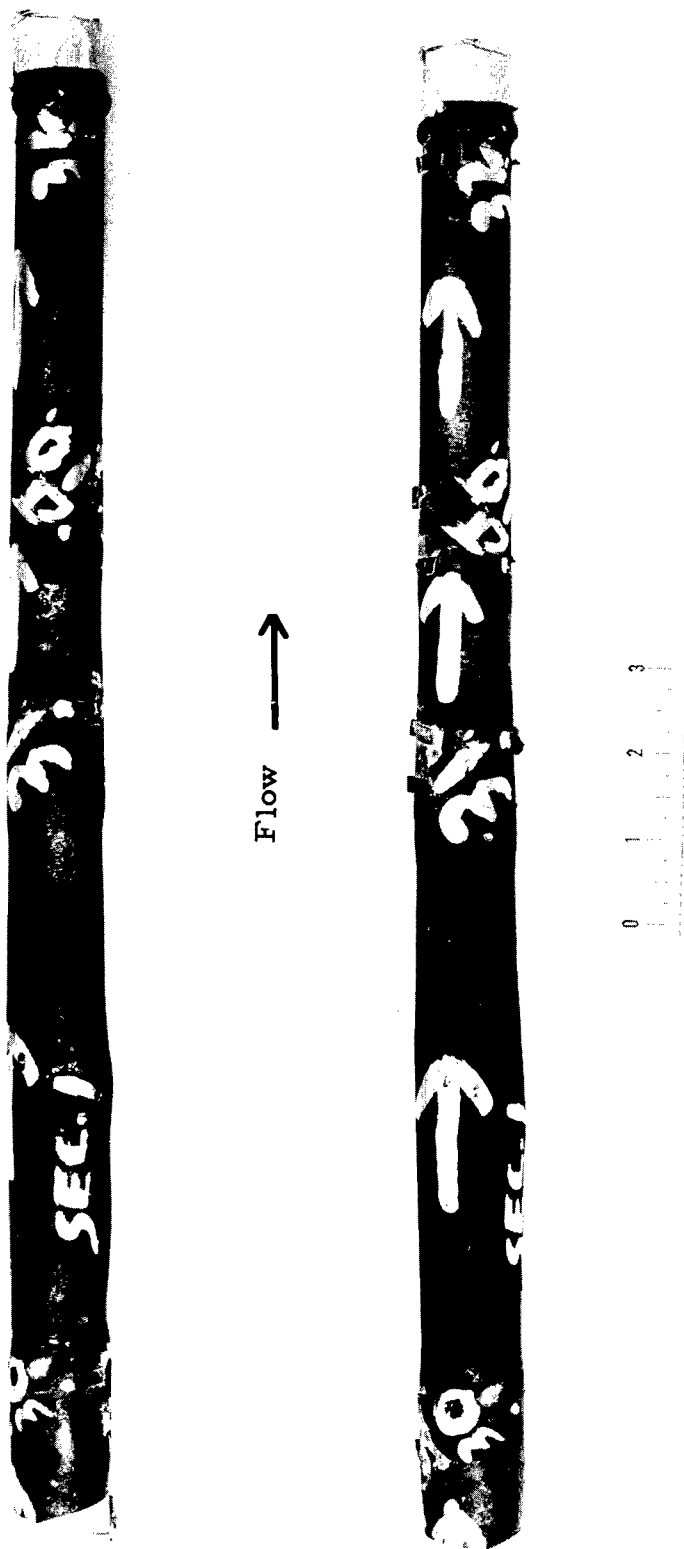
Figure 27 Appearance of the Superheater Outlet Section Showing the Deformation which Occurred.

The wall temperature of this failed portion of the superheater, by excessive creep, was $1405 \pm 10^{\circ}\text{F}$ as indicated and recorded by several thermocouples. At this elevated temperature, the creep strength of Croloy 9M is practically nil; stress to cause 0.001% per hour creep is less than 1500 psi. Since the available strength of the Croloy 9M was thus practically zero, the hoop stress for the superheater outlet section was calculated based only on the Type 316 SS clad portion of the tube and mercury vapor pressure of 269 psia. A value of 1965 psi hoop stress was obtained which is substantially lower than the reported 0.0001% per hour creep strength of 4000-5000 psi.^(6, 7) Since the hoop stress was not excessive for this austenitic steel, the reported temperatures were reviewed for possible error. Since three thermocouples reported $1405 \pm 10^{\circ}\text{F}$ and since the Type 316 SS did not have oxide scale, there was no reason to doubt the reported temperature. However, the observed metallurgical changes in the Type 316 SS mentioned above may be the cause of the accelerated creep and thus could be the primary cause of failure of the tubing. Obviously, the cause of the creep failure of the duplex tubing in the superheater outlet section cannot be determined without further mechanical testing.

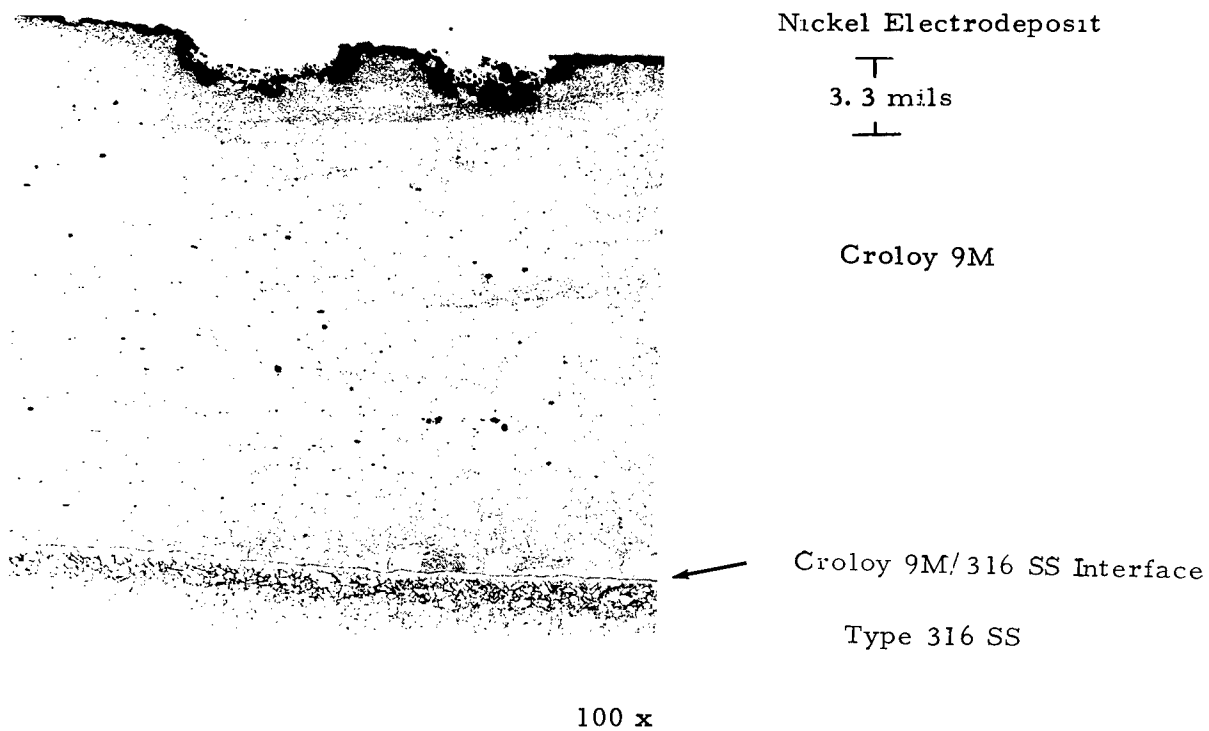
Figure 32. Intergranular Corrosion of Boiler Midsection.
Etchant - Carapella

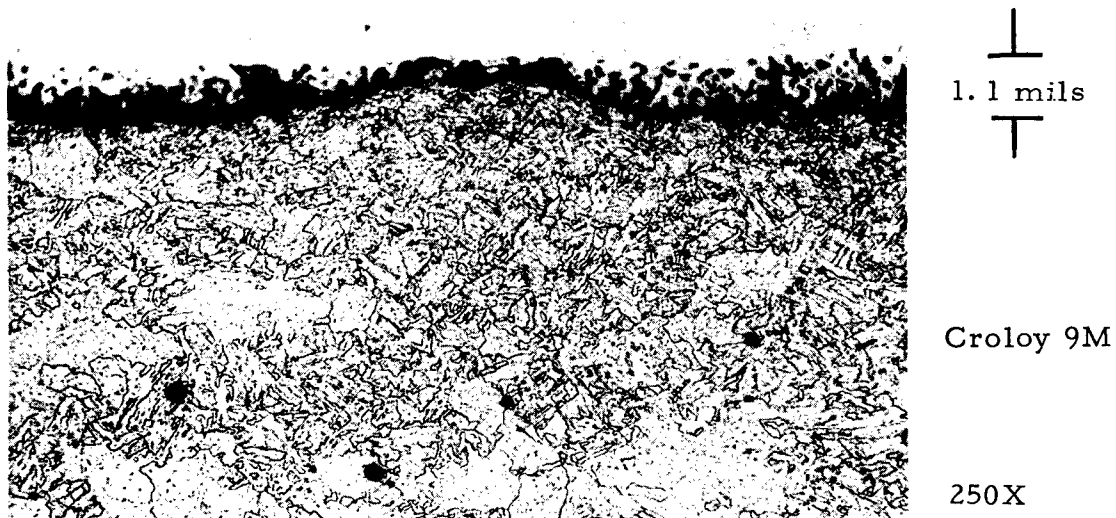
Figure 34. Intergranular Corrosive Attack of Boiler Wall Near Outlet.

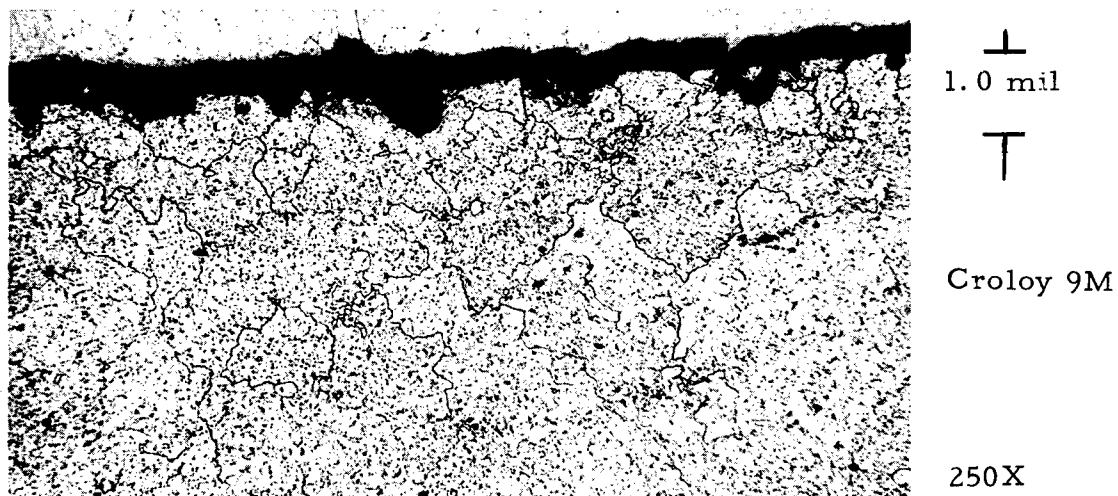
Figure 35. Typical Intergranular Corrosion of Croloy 9M at Inlet to Superheater.

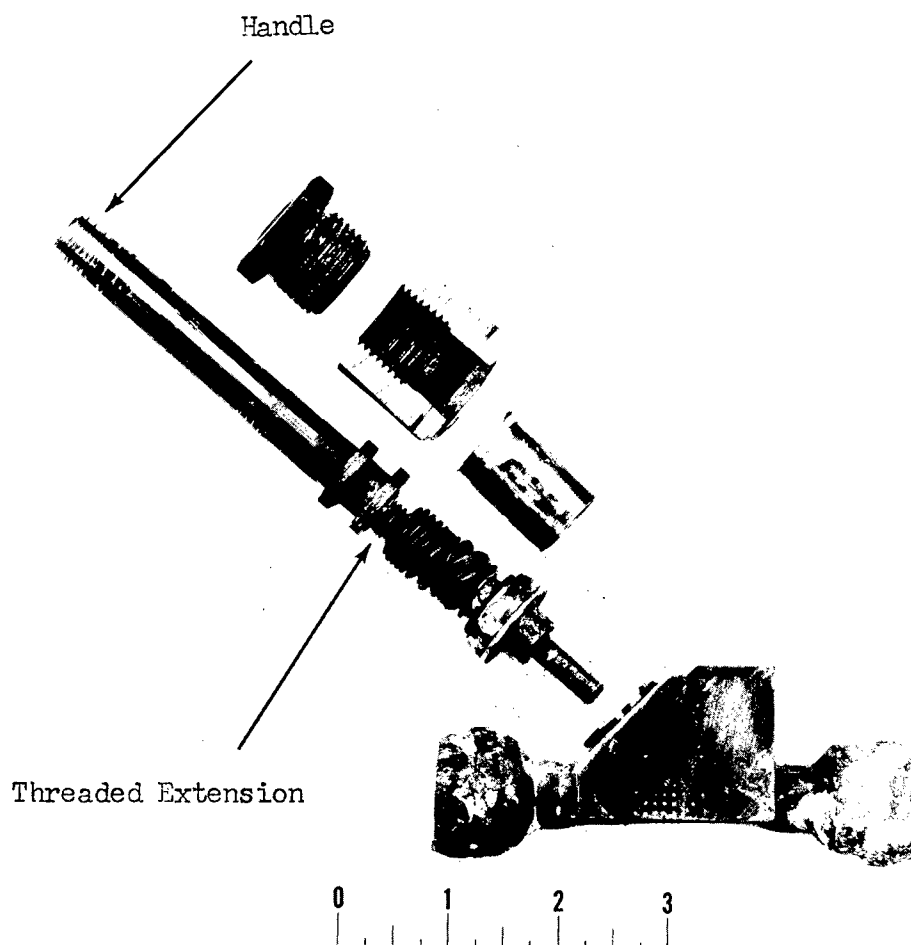
Deposition and corrosive and/or erosive attack were observed, after 448 hours of loop operation, in a Croloy 9M throttling valve located at the superheater outlet.

Figure 42. Disassembled Croloy 9M Throttling Valve.

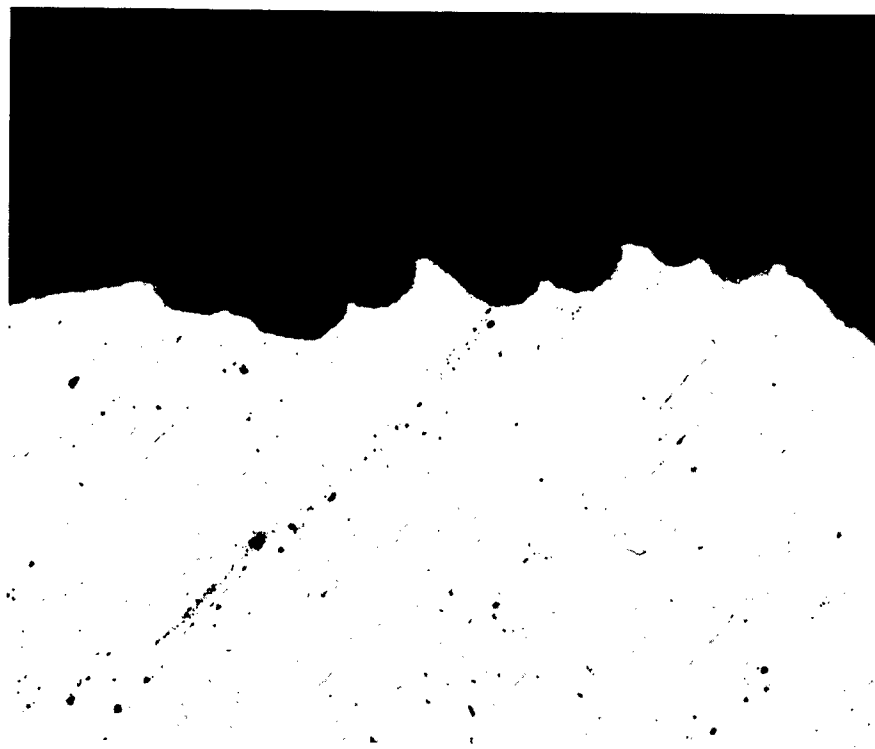
Figure 51. Attack on the Stem of the Croloy 9M Throttling Valve.
